# Manhole Inspection Summary

Manhole # S43C2\_006MH

Insp Date: **12/12/07 1:10 PM**

**Location** Address: **3901 West Bay Ave**

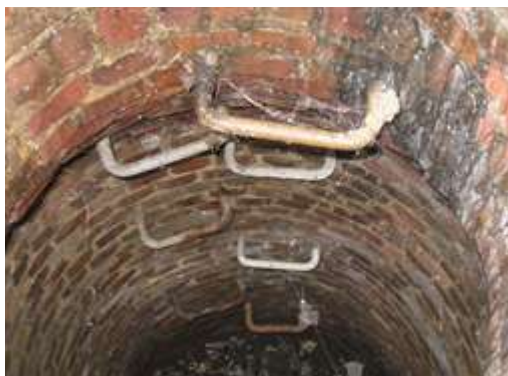
Steps

**Steps** Count: **7** Missing: **0** ☒ Corroded

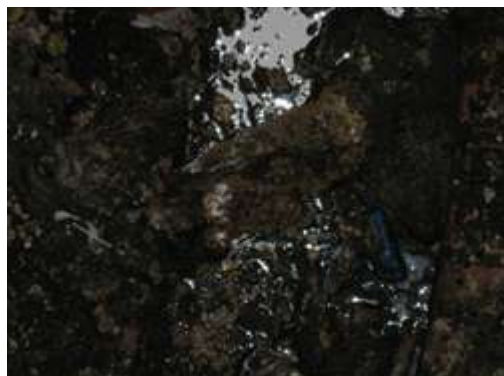
Defect 2

Debris in channel

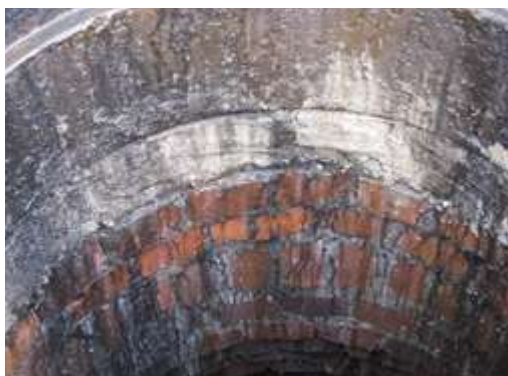
Defect 1

Infiltration: ☐ None ☐ Joint ☐ Cracks ☒ Mortar ☐ Roots ☐ Wall

Mortar

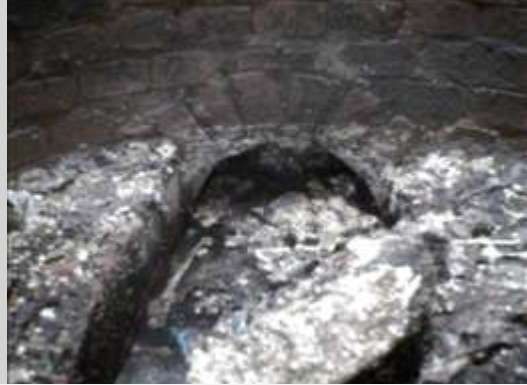
12 O'Clock Outflow

Pipe Height: **12** (in.) Rod and Bar (Angled)  
Pipe Material: **Clay** ☐ Pipe Lined  
Invert Depth: **11.91** (ft.) Flow Characteristics: **None**  
Deposits: ☐ None ☒ Mud ☒ Sludge ☒ Debris ☐ Grease  
Silt Depth: **6** (in.) Deposits Extent: **Medium**  
Infiltration: **None** Pipe Seal Cond: **Sound**

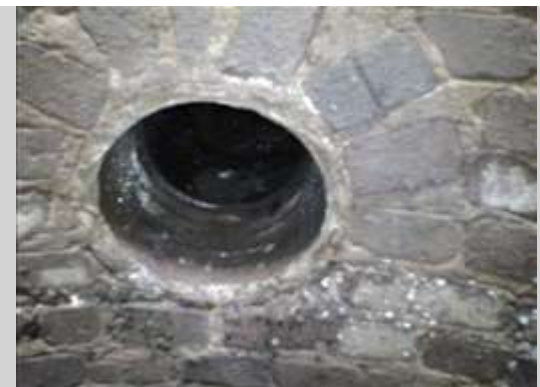
5 O'Clock Inflow

Pipe Height: **9.6** (in.) Rod and Bar (Angled)  
Pipe Material: **Clay** ☐ Pipe Lined  
Invert Depth: **8.40** (ft.) Flow Characteristics: **None**  
Deposits: ☒ None ☐ Mud ☐ Sludge ☐ Debris ☐ Grease  
Silt Depth: (in.) Deposits Extent:  
Infiltration: **None** Pipe Seal Cond: **Sound**

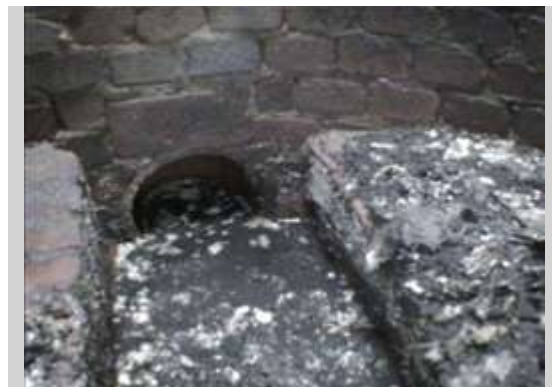
Drop In @ 5 O'Clock

Drop: **Outside** Rod and Bar  
Angled: **Yes** Reading: **10.66** (ft.)  
Inv Depth: **11.66** (ft.)  
Drop Condition: **Open**
